First Five-Year Review Report  
for  
Parker Landfill Superfund Site  
Town of Lyndonville  
Caledonia County, Vermont

September 2004

United States Environmental Protection Agency  
Region 1  
Boston, Massachusetts

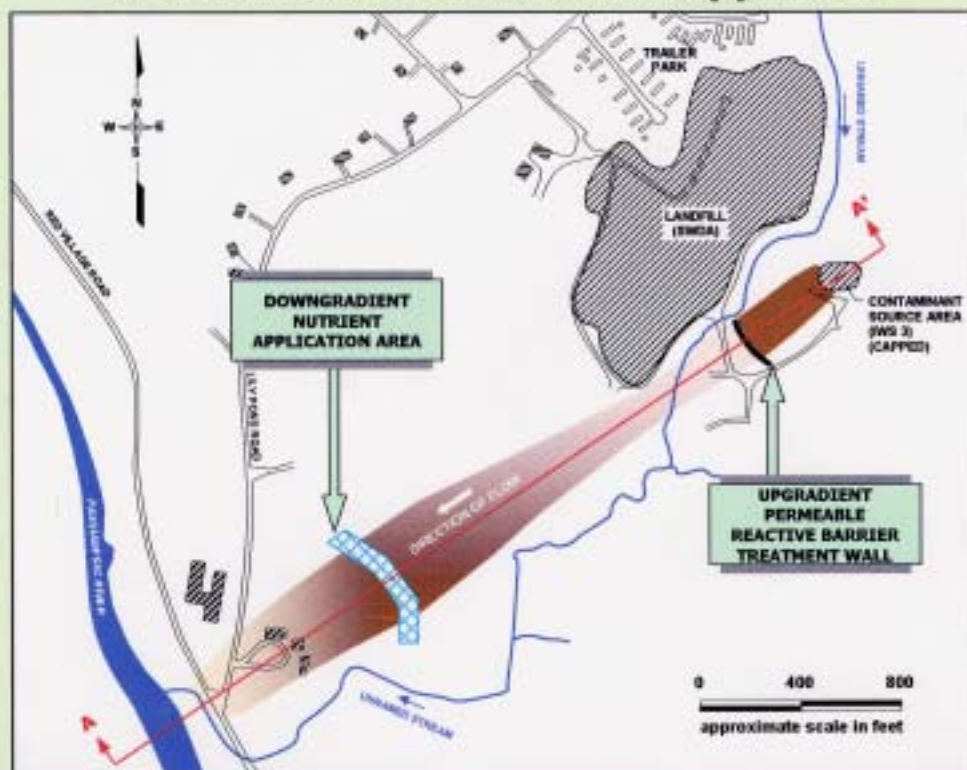
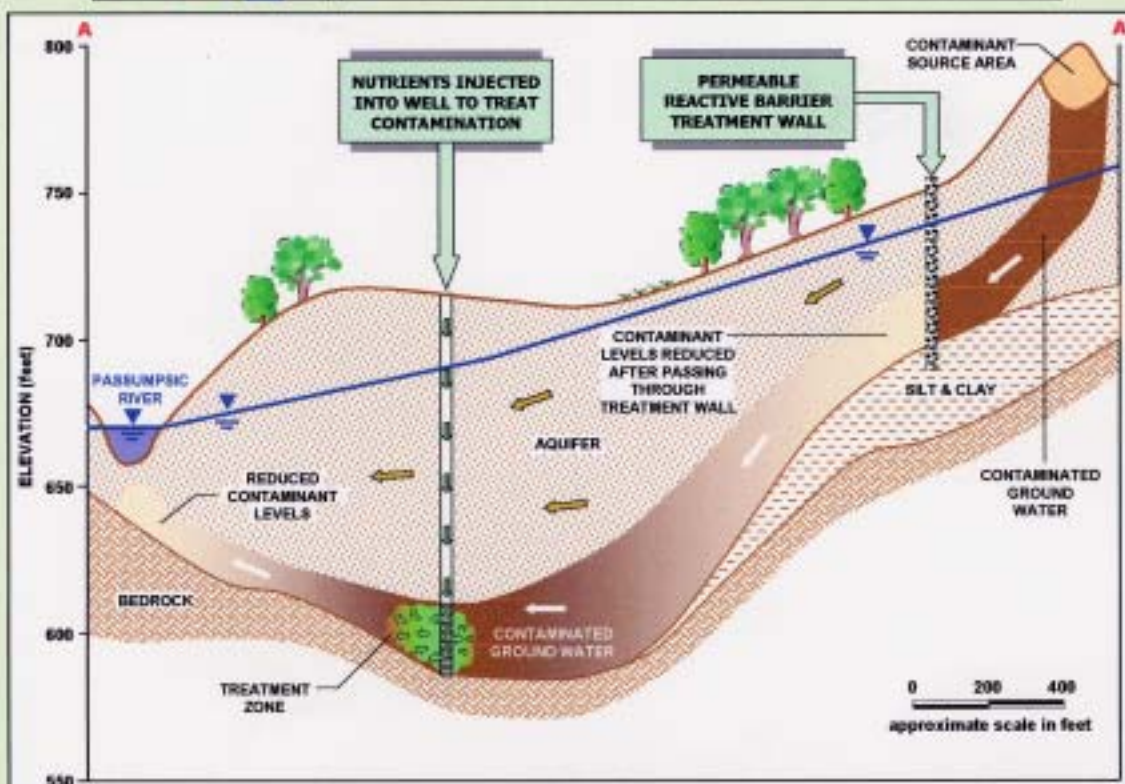
**FIGURE 3**  
**GROUNDWATER**  
**REMEDATION APPROACH**  
PARKER LANDFILL  
LYNDONVILLE, VERMONT

Two Pre-Design Technical Reports were completed by URS in 2003 and 2004 to evaluate the feasibility of the preferred remedial alternatives based on data gathered during pre-design field activities. The “Downgradient Pre-Design Technical Report” dated November 7, 2003, evaluates the feasibility of the use of in-situ bioremediation technology (i.e., nutrient injection) to enhance natural attenuation/biodegradation of chlorinated aliphatic hydrocarbons in the groundwater downgradient of the landfill. This report concluded that a bioenhancement technology may be effectively applied to the area of contaminated groundwater downgradient of the landfill, based on the determination that geochemical conditions observed in the study area are favorable for this technology. The nutrients recommended for application at the site, based on the pilot study, include sodium lactate (source of organic carbon), nitrogen, and phosphorus. The proposed location of the downgradient nutrient injection well field is shown in Figure 3.

The “Draft Source Area Pre-Design Technical Report” dated January 9, 2004, evaluates the feasibility of a zero-valent iron PRB wall to passively intercept the upgradient portion of the VOC-contaminated plume, and to effectively reduce concentrations of chlorinated VOCs in groundwater at the source area. This report concluded, based on column testing and bench-scale studies, that a zero-valent iron PRB would be effective in reducing concentrations of chlorinated VOCs to below IGCLs in the study area. Therefore, URS recommended full-scale design and implementation of a zero-valent iron PRB. The proposed location of the PRB is shown in Figure 3.

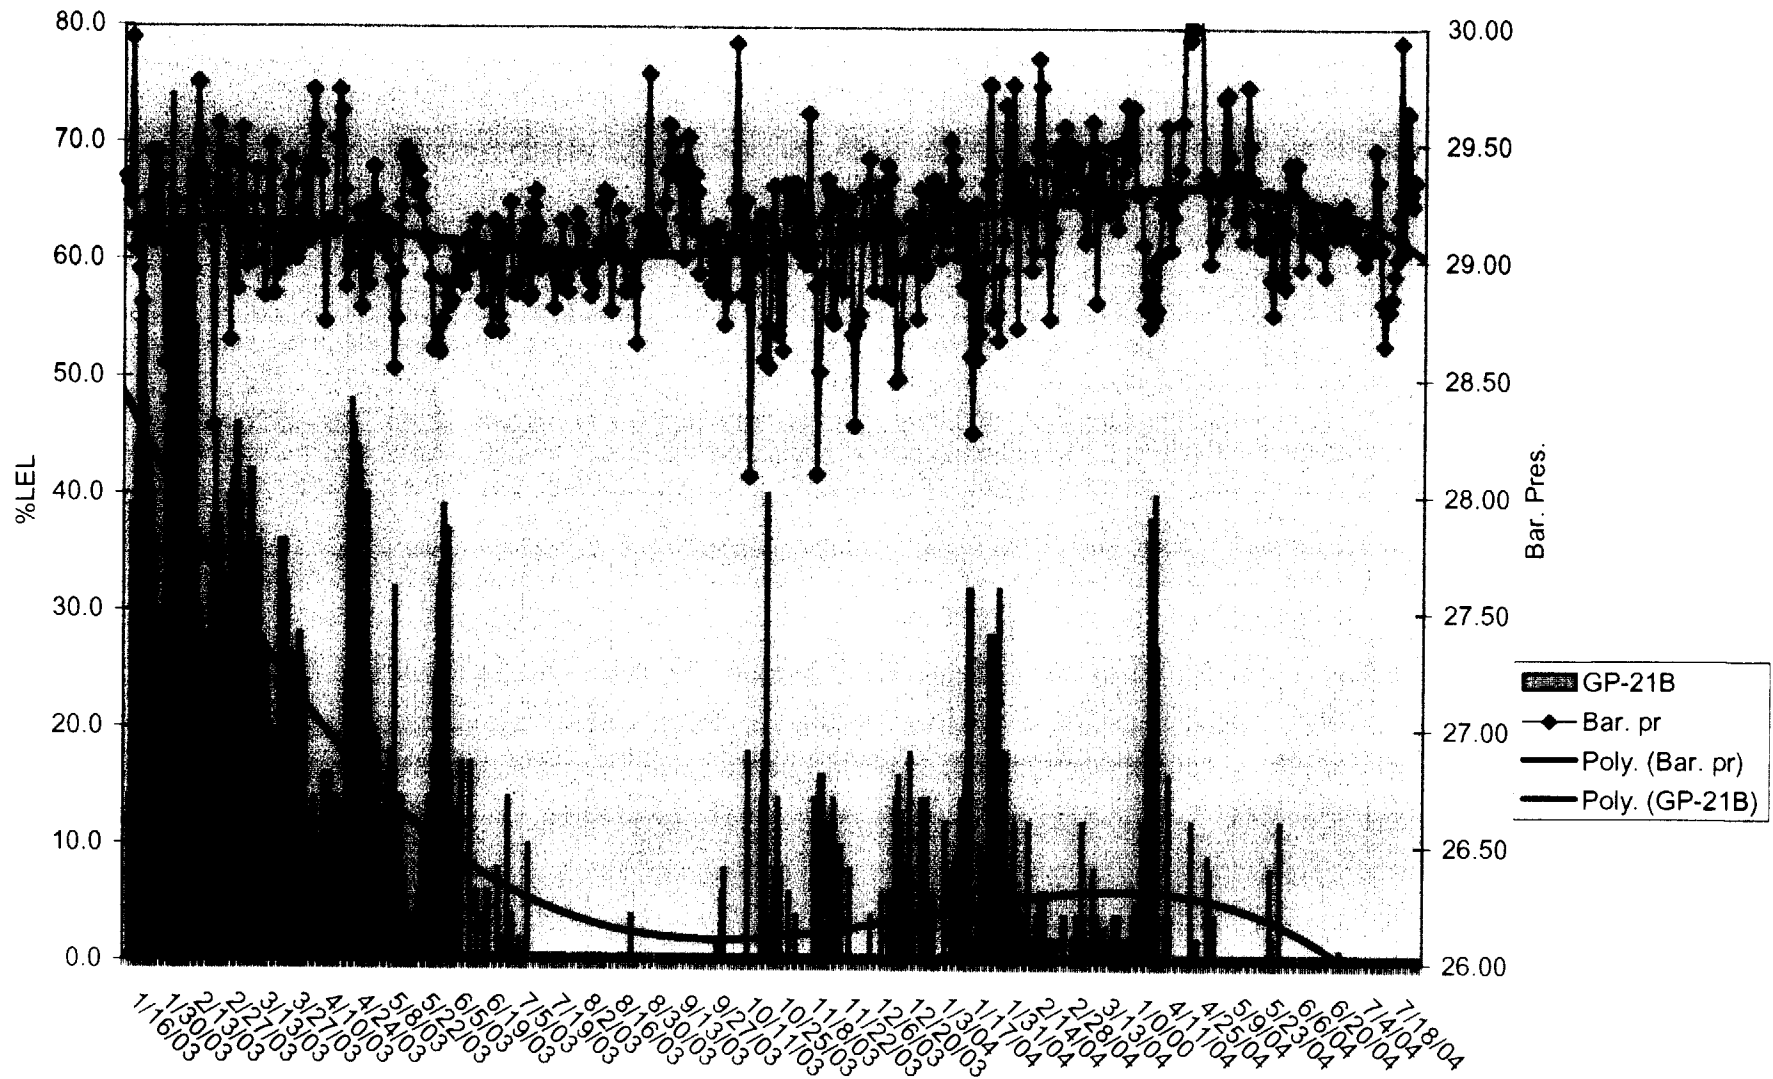
Figure 6 Landfill Gas Concentration Trend for Shallow Probe GP21B

In general, the methane concentrations in landfill gas probes have declined since weekly balancing and optimization of the landfill gas management system started in January 2003. Figure 6 shows the daily methane concentration in percent of LEL as measured in the shallow probe with the highest, and most consistent detections (GP-21B). The barometric pressure and fourth order polynomial trend lines were added for comparison. The graph shows an overall decrease in concentration with what appears to be a seasonal increase in concentrations during the winter months. The corresponding deep gas probe, GP-21A shows a similar trend in gas concentration (Figure 7).

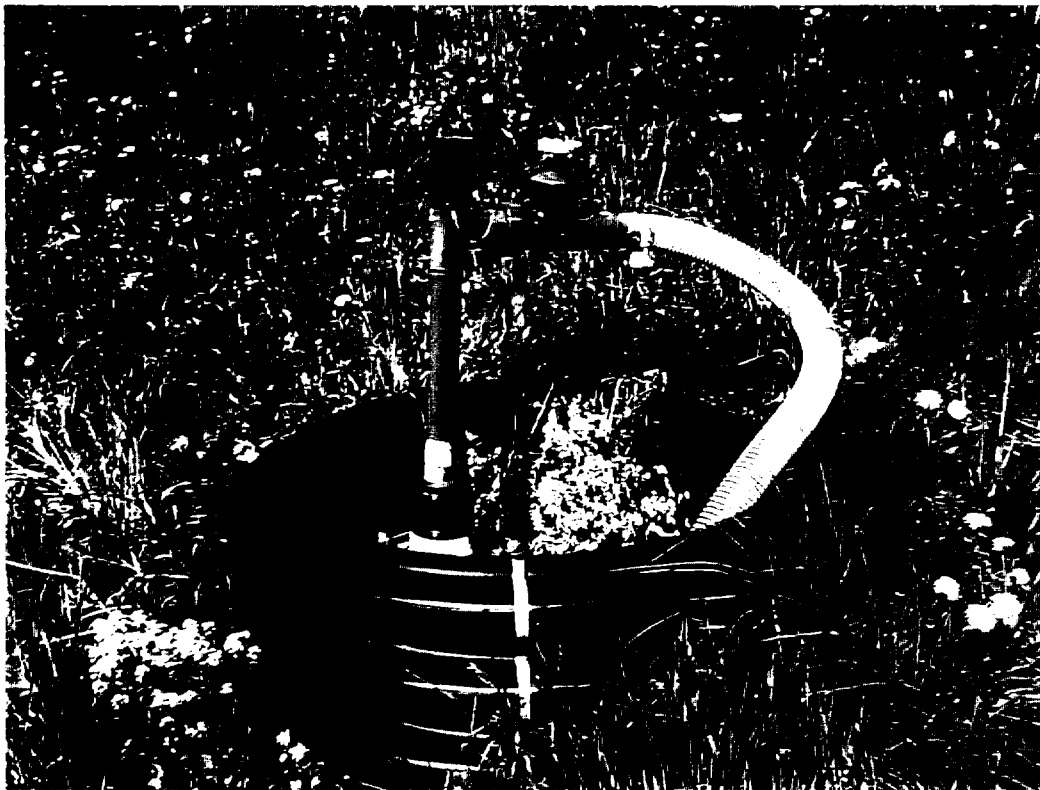
Photo 9 Typical Gas Extraction Well (EW-1).

Cover penetrations through the SWDA landfill cover system include 17 active gas extraction wells (Photo 9) and one inactive gas well, and eight concrete vault structures that allow present and future utility poles to pass through the cover system. Four of the concrete vaults contain utility poles and four others are reserved for the possible installation of utility poles in the future.
